# Manhole Inspection Summary

Manhole # S45G2\_006MH

**Location** Address: **1516 Olmstead-Locust** Cross Street: **Pennington Ave.**

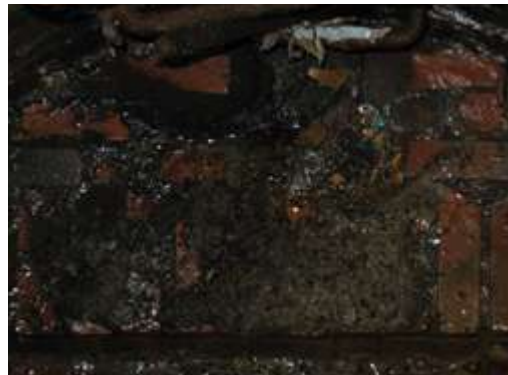
Defect 2

Waste on bench

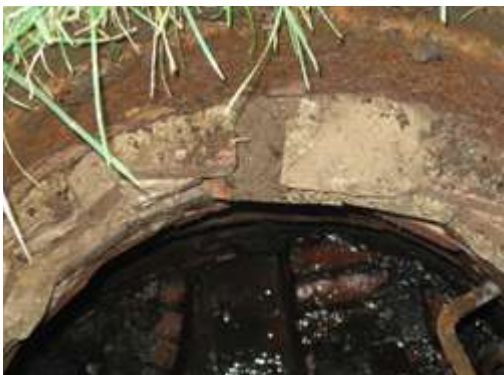
Defect 1

**Frame** Offset: **3.5** (in.) Condition: ☒ Sound ☐ Cracked ☐ Leaks

Frame offset

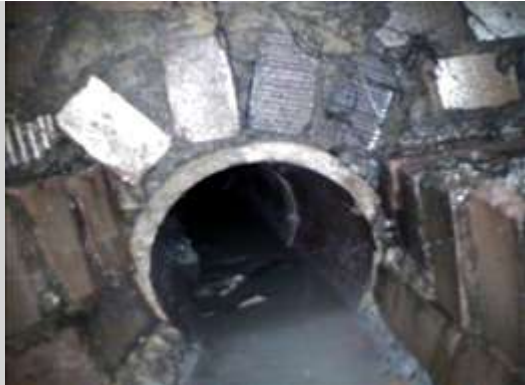
12 O'Clock Outflow

8 in. Circular Gravity Sewer  
Pipe Out @ 12 O'Clock

Pipe Height: **8.4** (in.) Rod and Bar (Angled)  
Pipe Material: **Clay** ☐ Pipe Lined  
Invert Depth: **8.74** (ft.) Flow Characteristics: **Fast**  
Deposits: ☒ None ☐ Mud ☐ Sludge ☐ Debris ☐ Grease  
Silt Depth: (in.) Deposits Extent:  
Infiltration: **None** Pipe Seal Cond: **Sound**

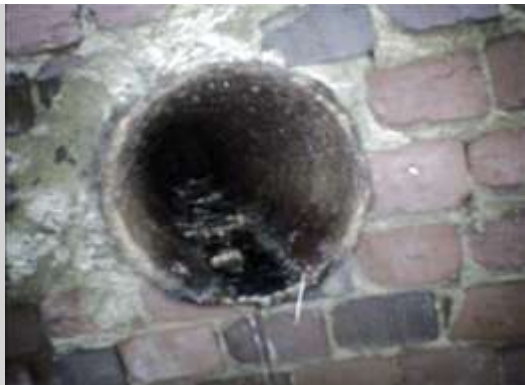
5 O'Clock Inflow

6 in. Circular Service Sewer  
Pipe In @ 5 O'Clock

Pipe Height: **7.2** (in.) Rod and Bar (Angled)  
Pipe Material: **Clay** ☐ Pipe Lined  
Invert Depth: **4.75** (ft.) Flow Characteristics: **Slow**  
Deposits: ☒ None ☐ Mud ☐ Sludge ☐ Debris ☐ Grease  
Silt Depth: (in.) Deposits Extent:  
Infiltration: **None** Pipe Seal Cond: **Sound**

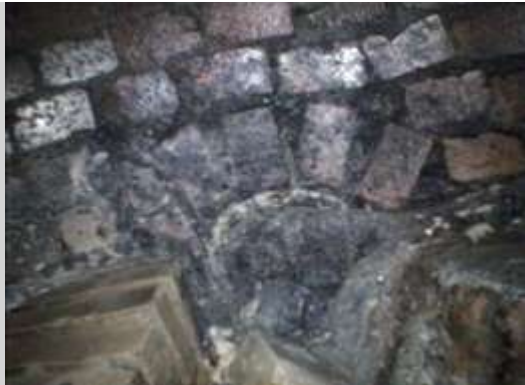
6 O'Clock Inflow

4 in. Circular Gravity Sewer

Pipe In @ 6 O'Clock

Pipe Height: **3.6** (in.) Rod and Bar (Angled)

Connects To: **Stub connection / abandoned**

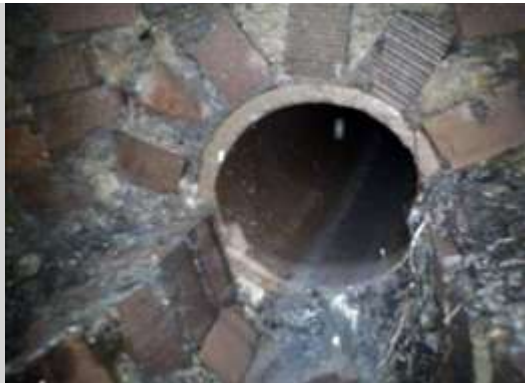
9 O'Clock Inflow

8 in. Circular Gravity Sewer

Pipe In @ 9 O'Clock

Pipe Height: **8.4** (in.) Rod and Bar (Angled)

Infiltration: **None** Pipe Seal Cond: **Sound**
